**Dam Safety Assessment of CCW
Impoundments**

**Reid/Green/HMP&L Station II
Report**

**Lockheed Martin
Contractor for the USEPA**

October 2009

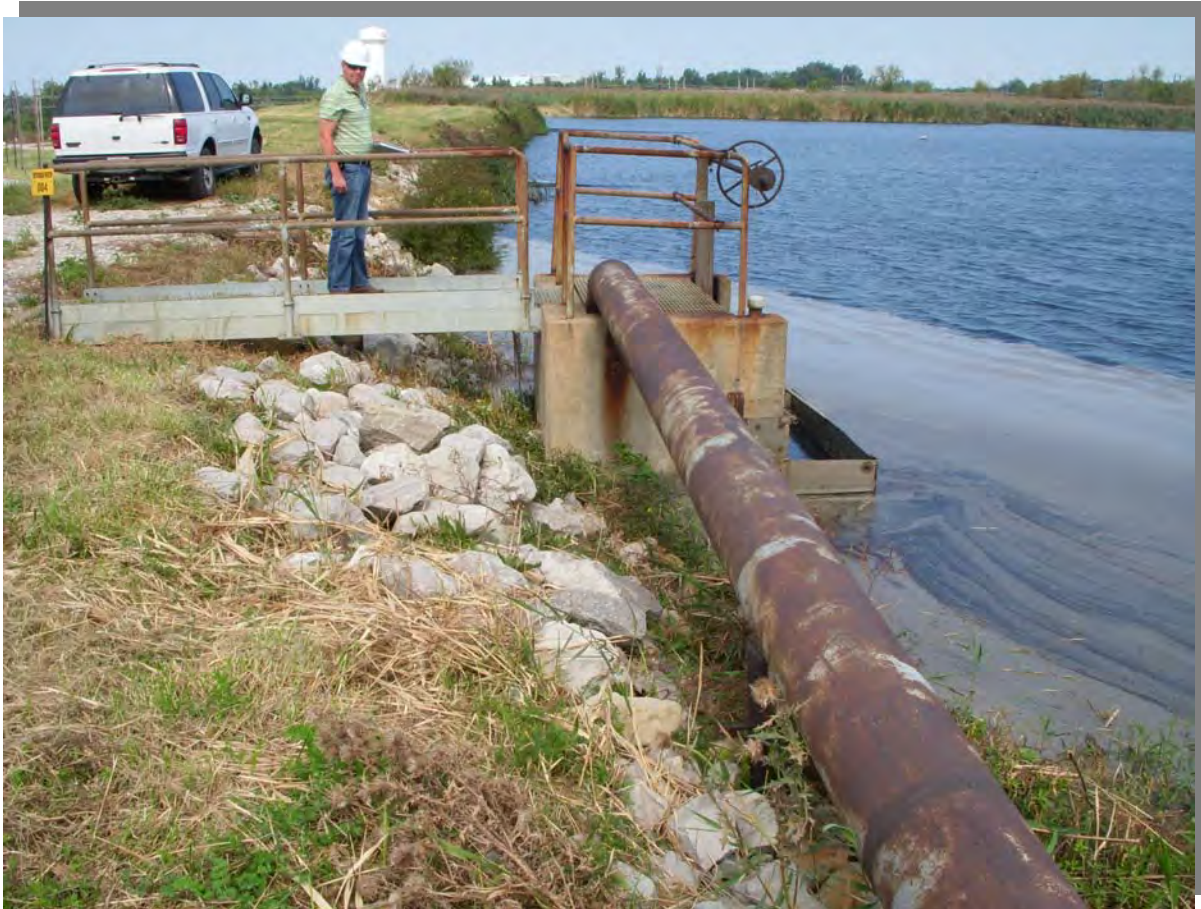
- A mature willow tree is growing on the eastern crest and inboard slope.
- The outlet structure appeared to be in good condition and functioning normally (Appendix B – Photo 1) .

Photo 1 – View of pond outlet structure

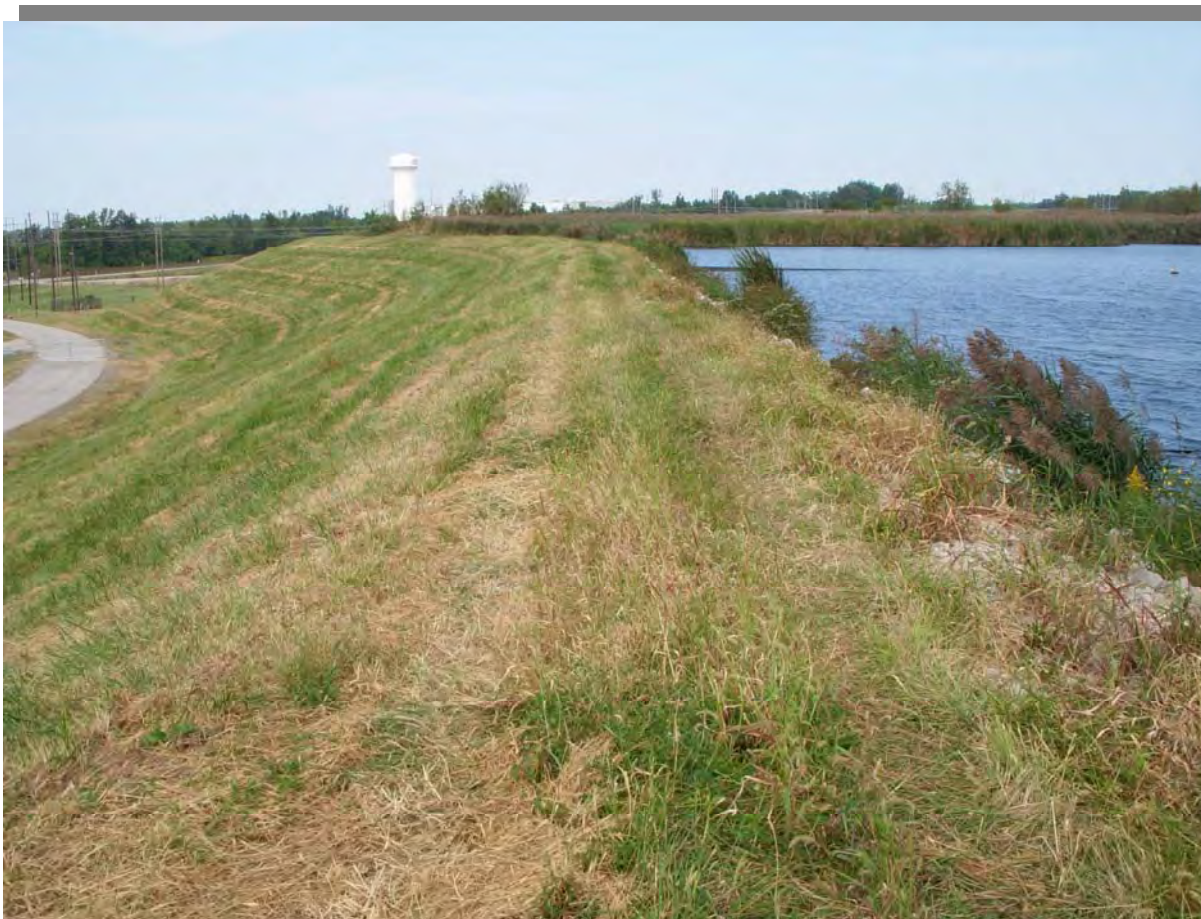
Photo 2 – View of south dike crest looking west.

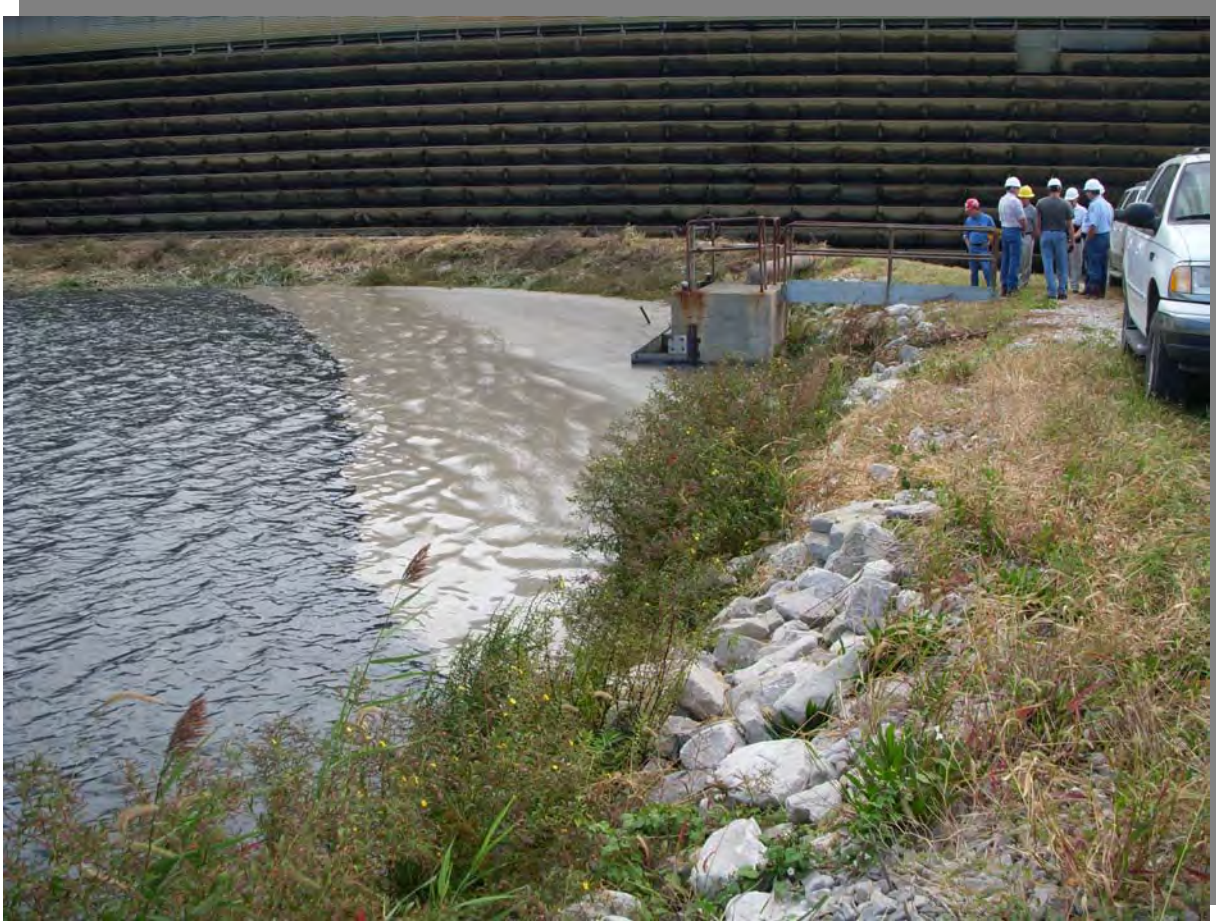
Photo 3 – View along inboard slope of south dike looking east. Note riprap armoring.

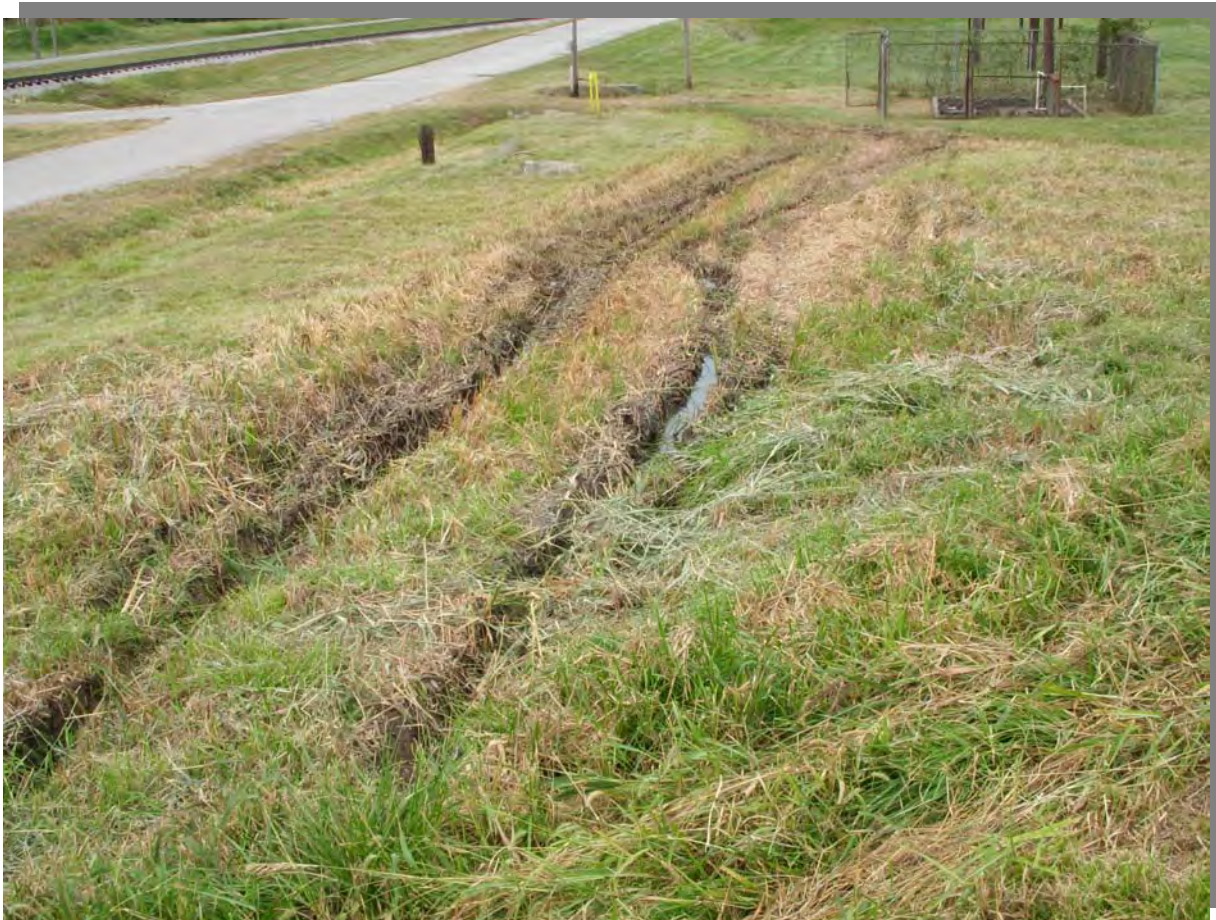
- The outboard slope and crest were covered with well maintained grass. The crest has been rutted by the mowing tractor in a few isolated locations.
- Minor seepage was evident along the toe of the outboard southern and western slopes. The seepage rate was very low with no discernible flow. Seepage was observed to accumulate in rutted areas at the toe of slope created by the mowing tractor. The seepage is believed to be controlled discharge from the sand toe drain.

Photo 4 – Seepage and rutting along south outboard toe.

- Outboard toe – regrade the swale along the toe to improve drainage. The swale may need to be lined with alternate materials, such as crushed stone or concrete to alleviate the soft soil condition. Consider installing a V-notch weir to monitor seepage flow rate. Remove wooden poles and fill with compacted material consistent with the dike design.

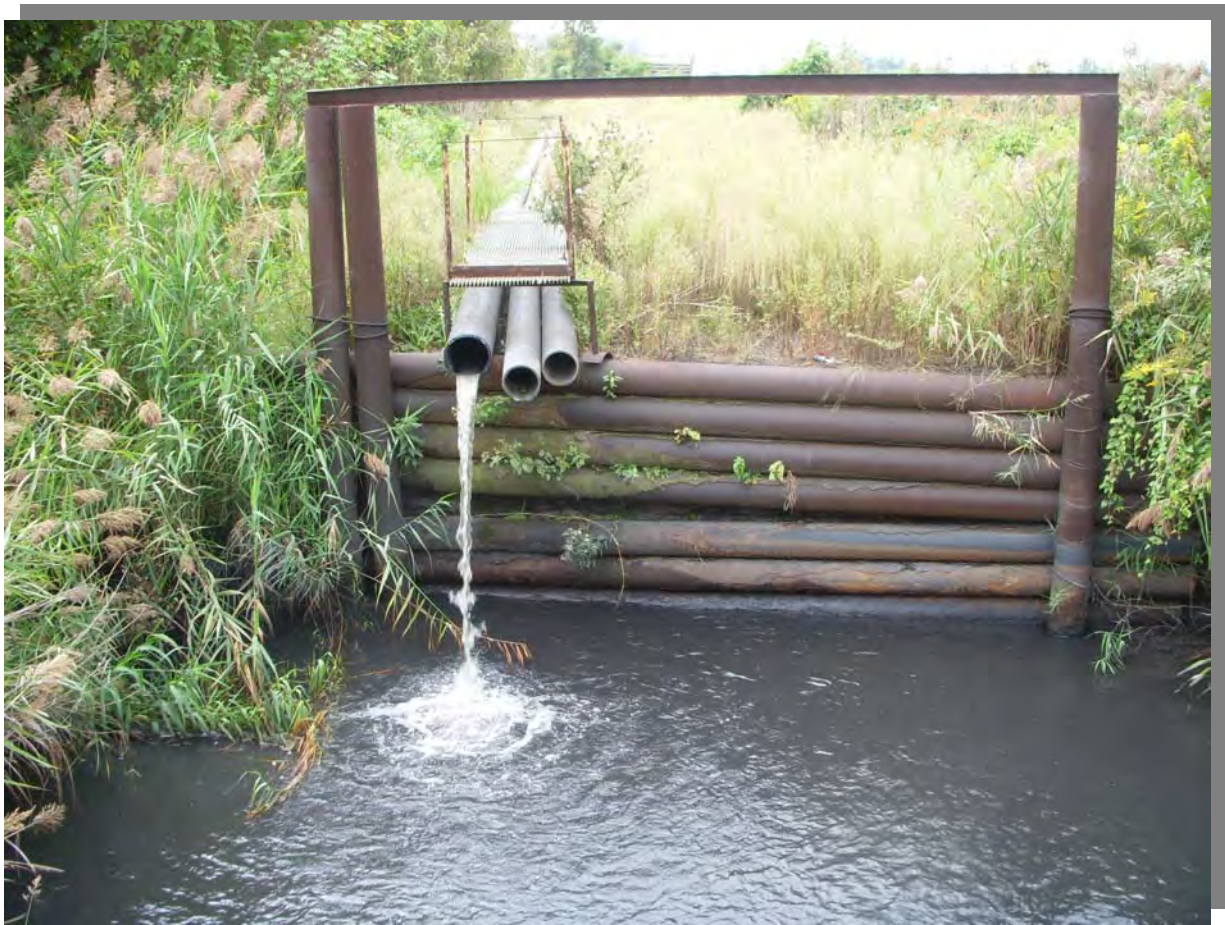
Photo 5 – Influent pipe discharging into northern ditch that parallels a portion of the northern inboard slope.

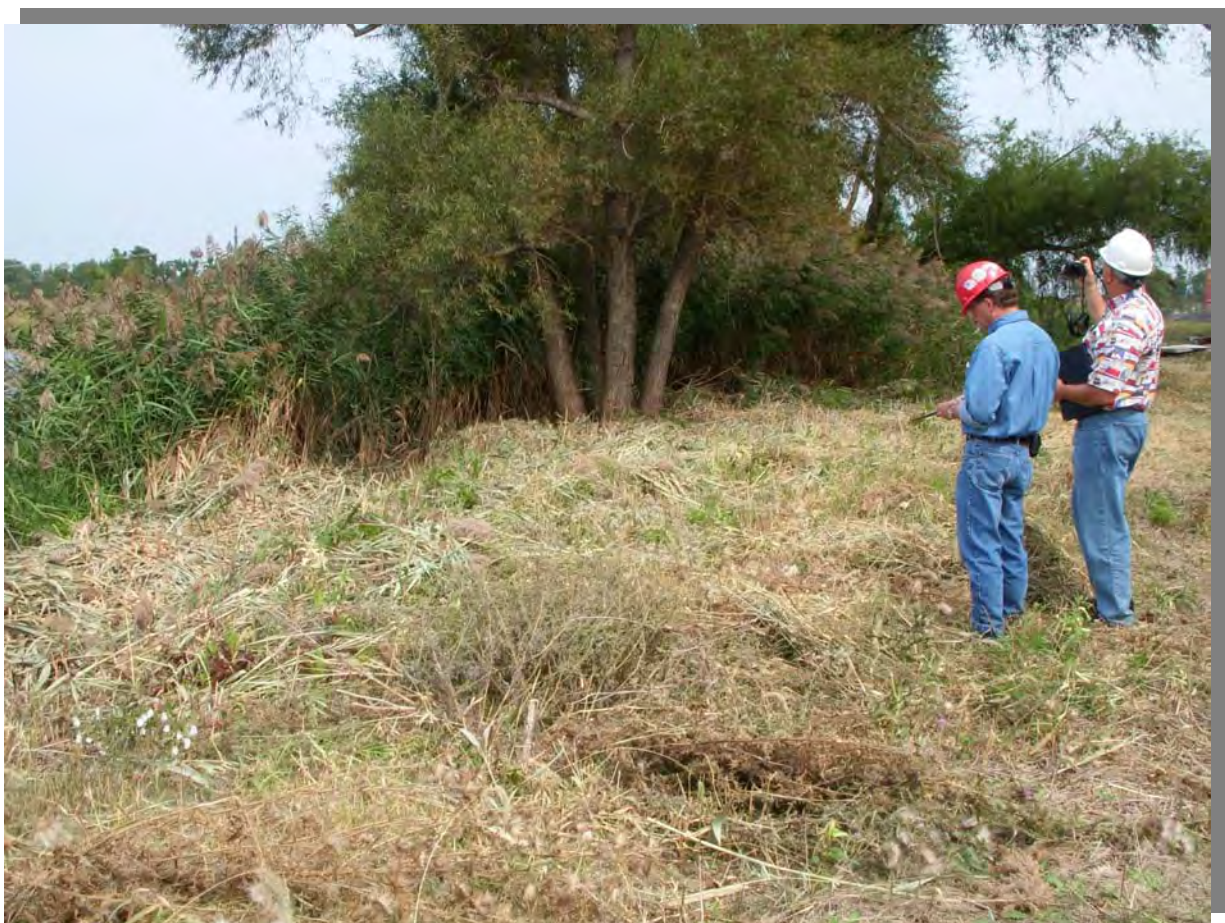
Photo 6 – East dike crest with willow tree.

- Crest – fill ruts on crest and re-establish vegetative cover. Remove willow tree from crest of eastern dike.
- Inboard slopes – repair eroded inboard slopes. Repairs should be completed in accordance with an engineered design. Inspect and maintain erosion that may develop on freeboard section of all inboard slopes on a regular basis. Keep vegetation under control to allow for visual inspection of the exposed portion of the slope above the waterline.

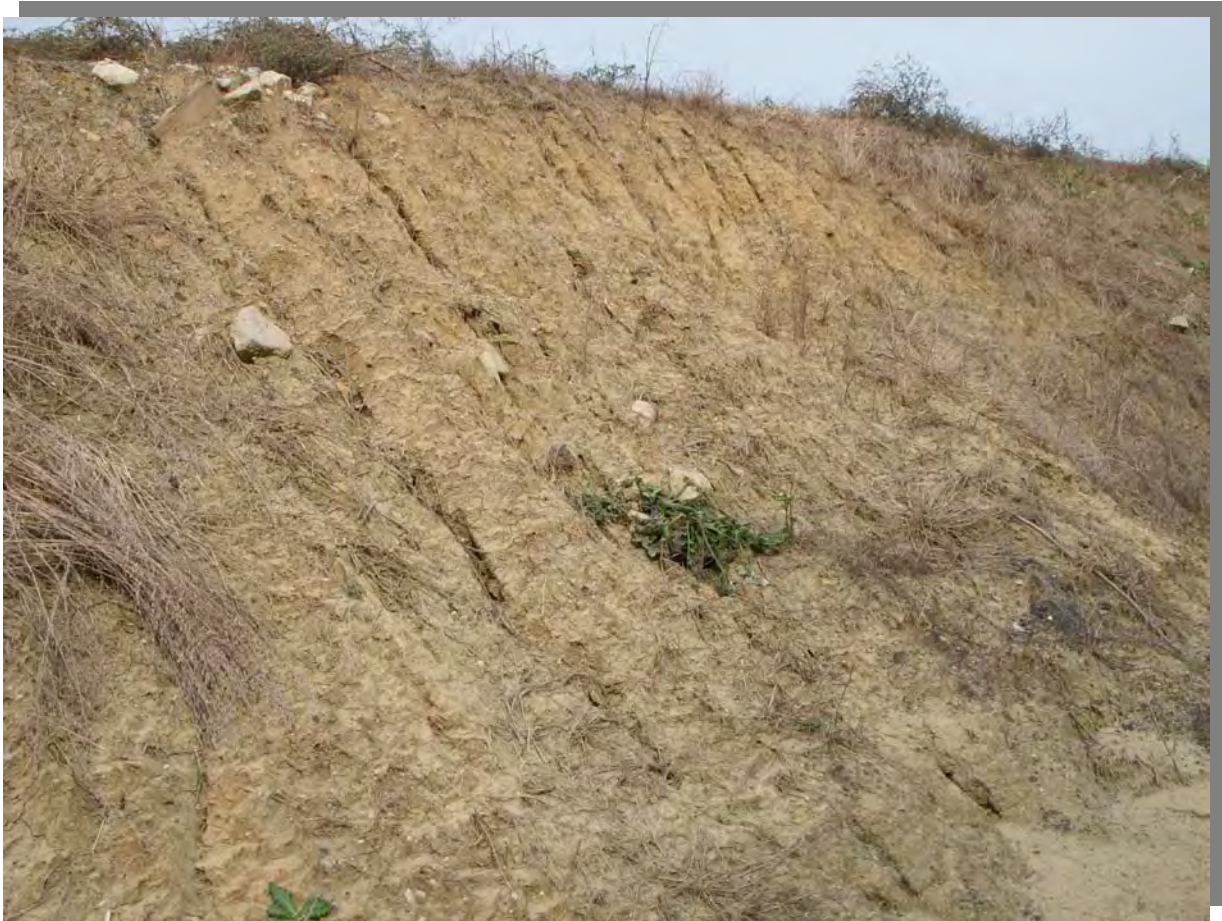
- Seepage from the sand fill underdrain at the outboard toe was observed to be clear. Rate noted as “trickle”.
- Erosion problems noted on downstream slope near cooling tower (east side)
- Three feet of freeboard was provided above the normal pond water level
- Area of ponded water created by ash berm near NE corner should be investigated to ensure water level is not above existing ground level/crest elevation.
- Plans for repairs to deficient conditions cited in the report are underway.

Based on our conversations with Mr. David Lamb, PE of Associated Engineers, Inc., plans are underway to repair the erosion problems on the east outboard slope.

Photo 7 – East dike outboard slope impacted by excavation and erosion.

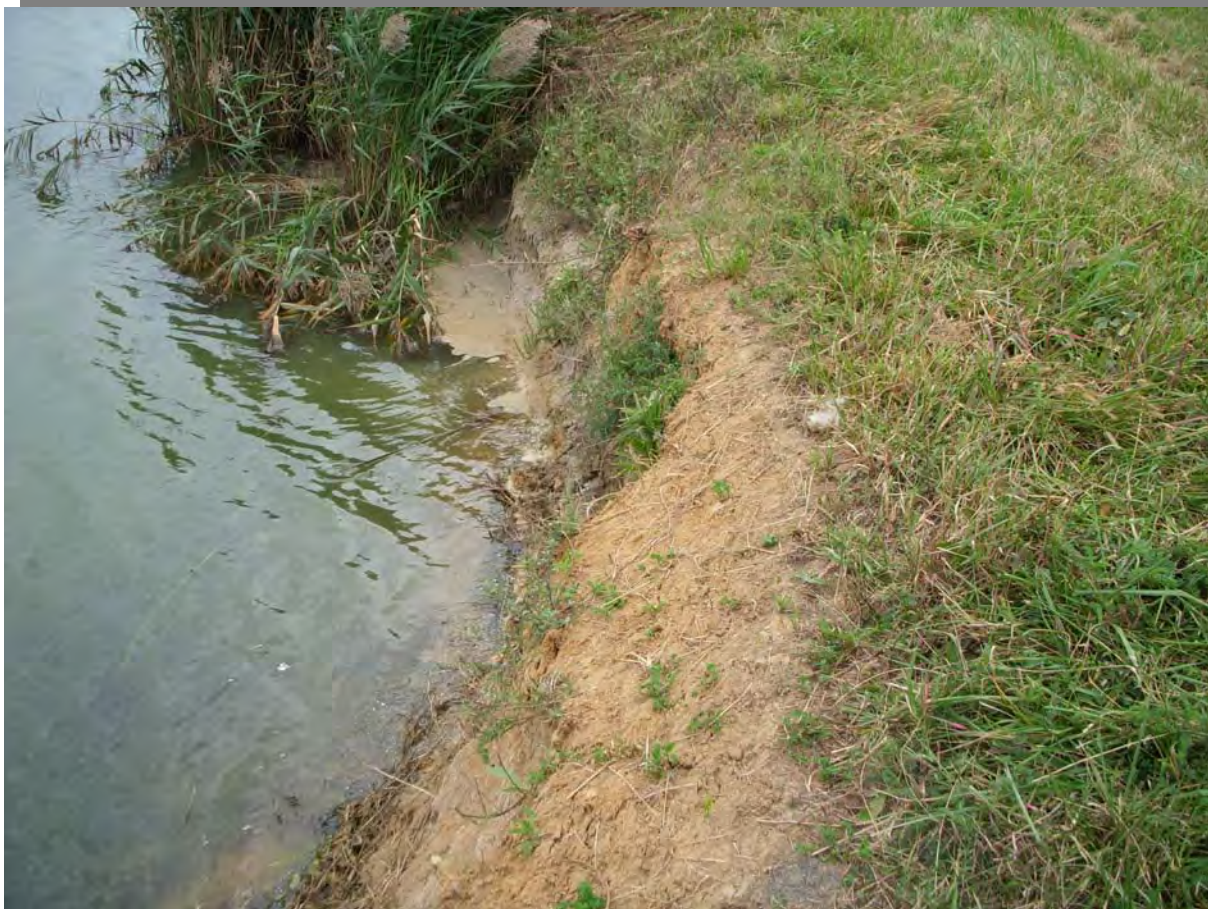
- The inboard slopes along portions of the pond were overgrown with reedy grasses such as fragmites (Appendix C – Photo 2).
- Some erosion of the exposed inboard slopes was observed along the west side of the pond.

- The west inboard slope is experiencing erosion due to wave action.
- The emergency outlet pipes are deteriorated and obstructed at the downstream end.

Photo 1 – Typical erosion of inboard slope on west side of pond.

- Inboard slopes – repair eroded inboard slopes. Repairs should be completed in accordance with an engineered design. Inspect and maintain erosion that may develop on freeboard section of all inboard slopes on a regular basis. Keep vegetation under control to allow for visual inspection of the exposed portion of the slope above the waterline.
- Emergency outlet – replace emergency overflow outlet pipes. Repairs should be completed in accordance with an engineered design.
- Outboard toe – regarded poorly drained swale along west and south toe to reduce ponding stormwater.
- Additional studies – perform geotechnical investigation, cross-sectional topographic survey, and slope stability analyses of critical slopes. Install piezometers to check phreatic levels within the embankment. Analyze for normal pool with steady state seepage, maximum surcharge pool, and seismic loading conditions.

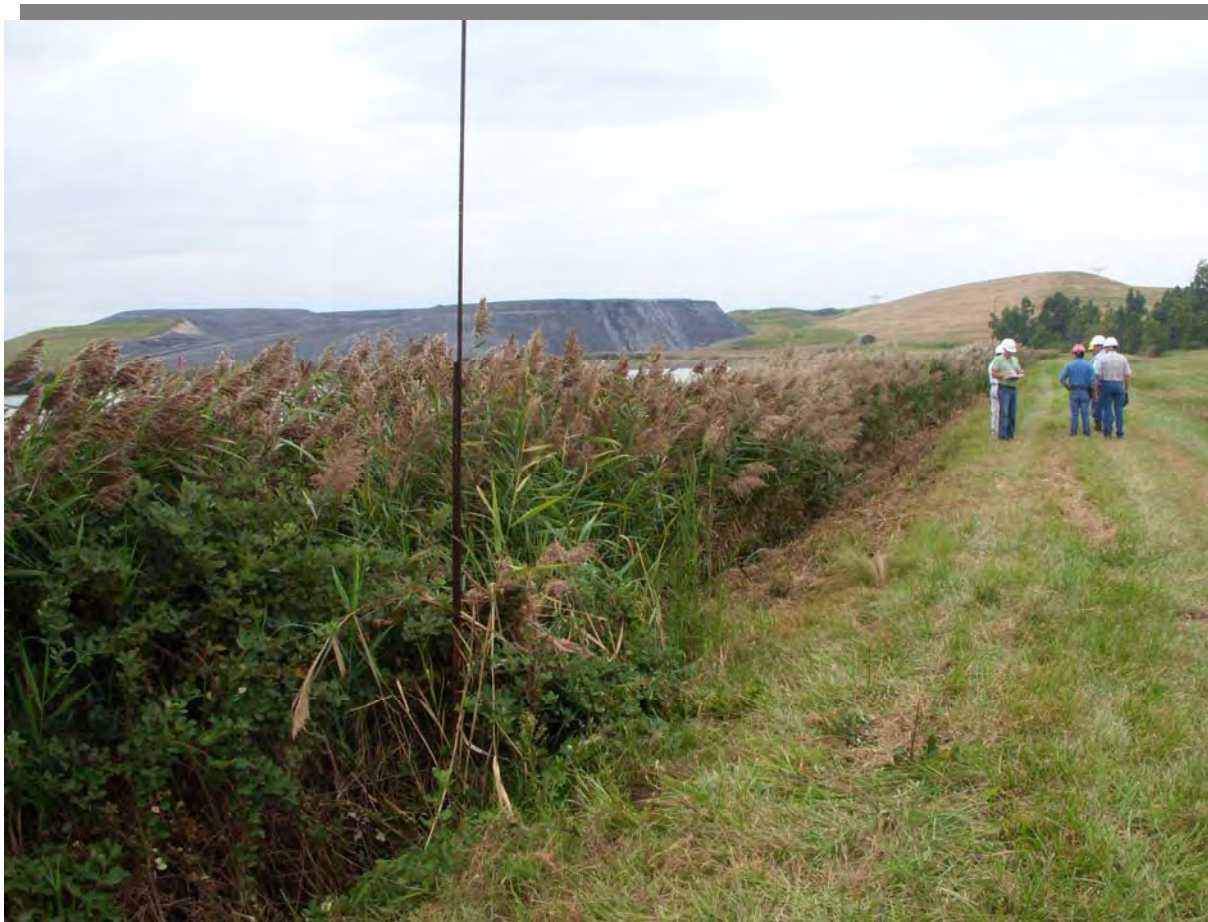
Photo 2 – Crest of low west dike looking south. Note heavy vegetation on inboard slope.

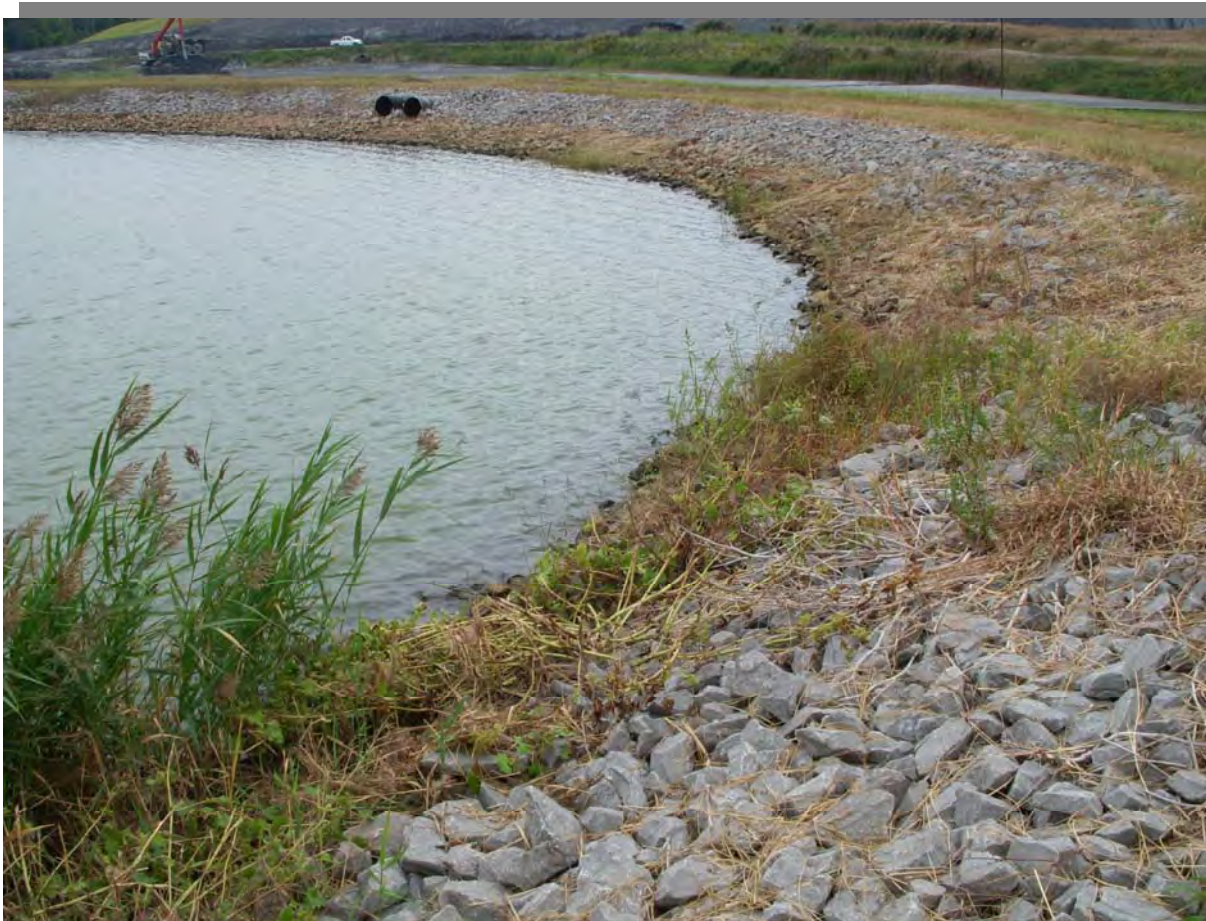
- The inboard slopes along the south end of the pond are armored with riprap to protect against wave action (Appendix C – Photo 3).
- Standing water (less than 6-inches deep) was observed within poorly drained swales along the western and southern embankment toe. The source of this water appears to be storm water and not seepage from the impoundment.

Photo 3 – Riprap-armored inboard slope of south dike. Note emergency overflow pipes in background.

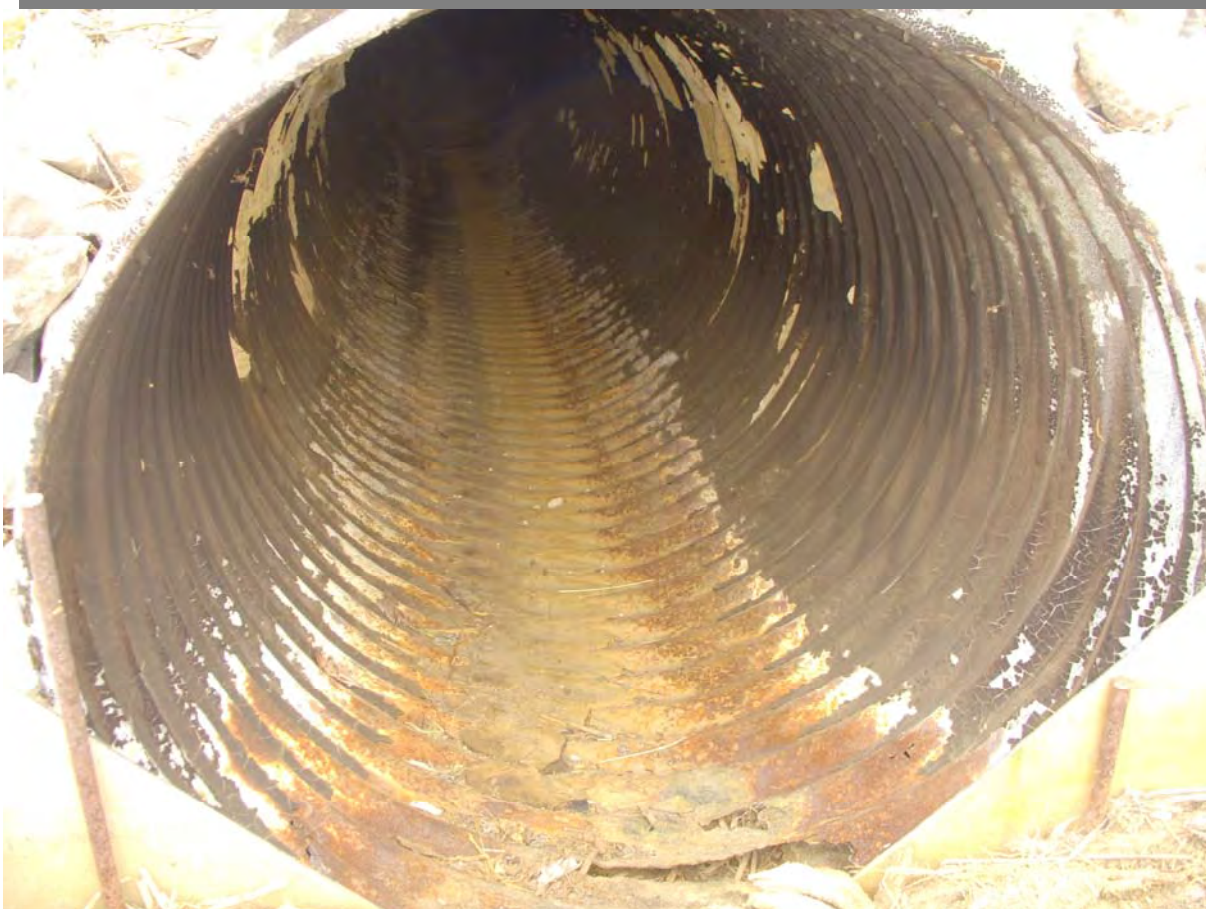
- The dual 30-inch emergency overflow pipes (CMP) located at the southwestern corner of the ash pond were observed to be deteriorated and damaged. These pipes were partially obstructed with silt at the discharge end. Our observations of the pipes indicated that they are rarely used (Appendix C – Photos 4 and 5).

Photo 4 – View of deteriorated 30-inch CMP emergency overflow pipe at upstream end.

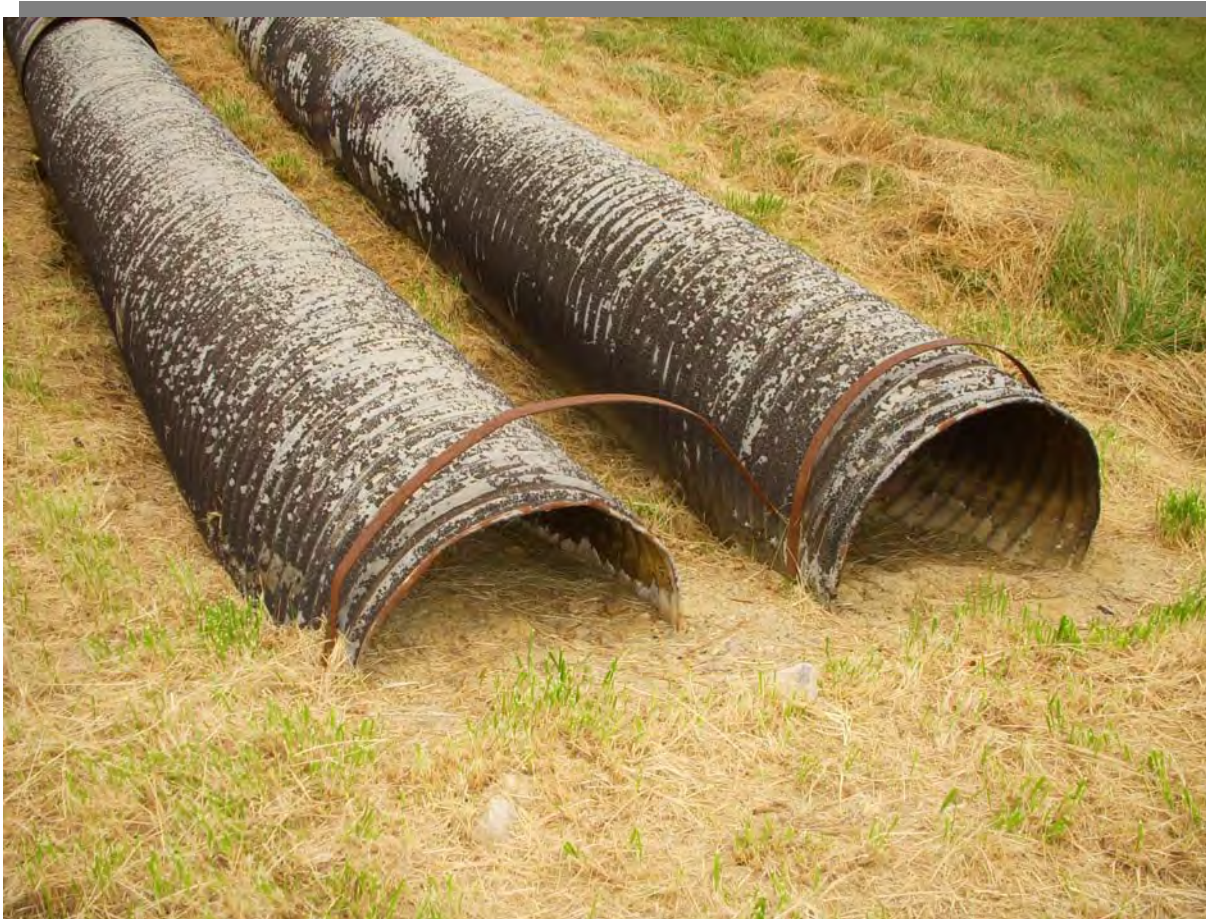
Photo 5 – Downstream end of emergency overflow pipes. Note siltation of outlet.

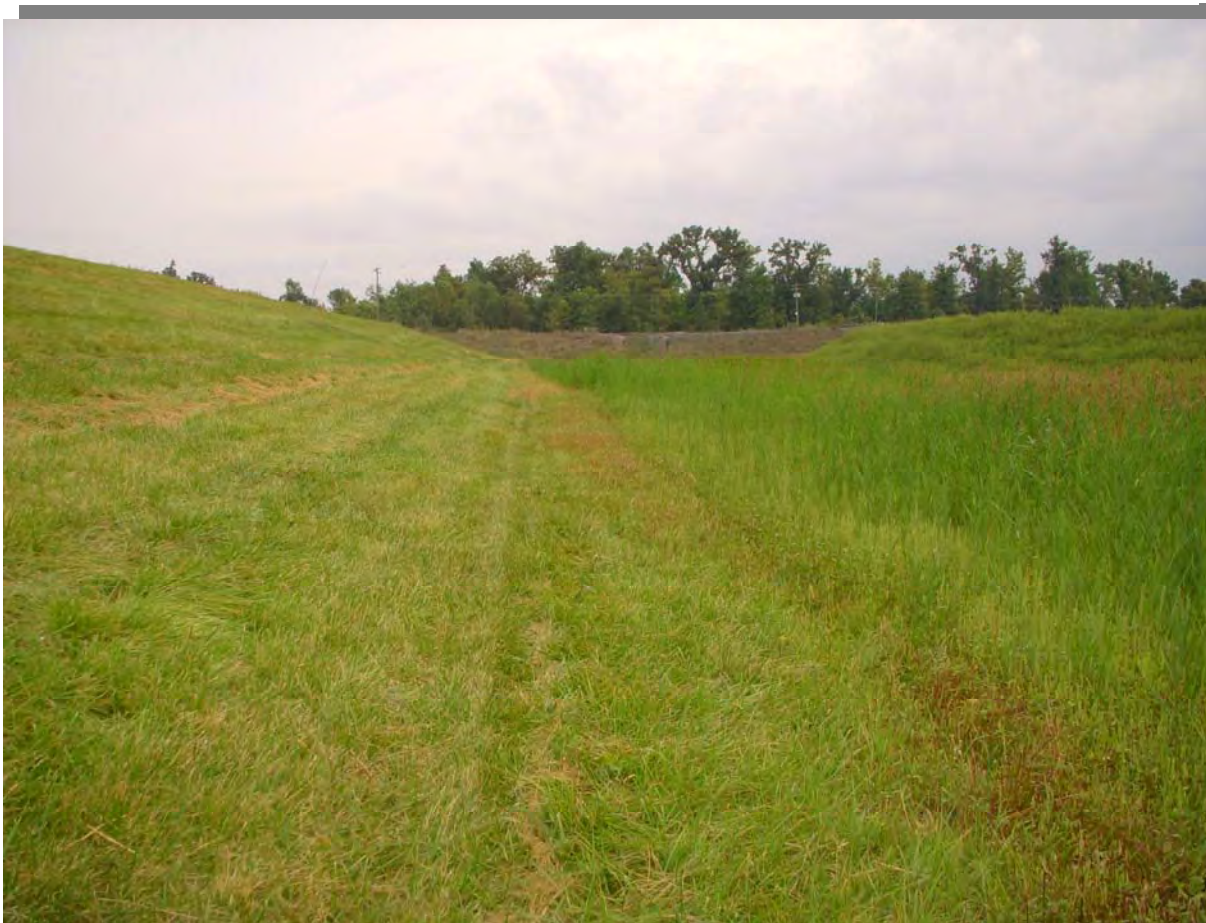
- The crest and outboard slopes appeared to be covered with well-maintained grass and in good condition (Appendix C – Photo 6).
- Bottom ash has accumulated above the normal pool elevation in much of the eastern portion of the pond. This area is used to stockpile excavated bottom ash which is allowed to drain, then loaded on trucks and hauled to the landfill located south of the ash pond. (Appendix C – Photo 7).

Photo 6 – View along outboard toe of south dike looking east. Note high vegetation in drainage swale beyond the toe.

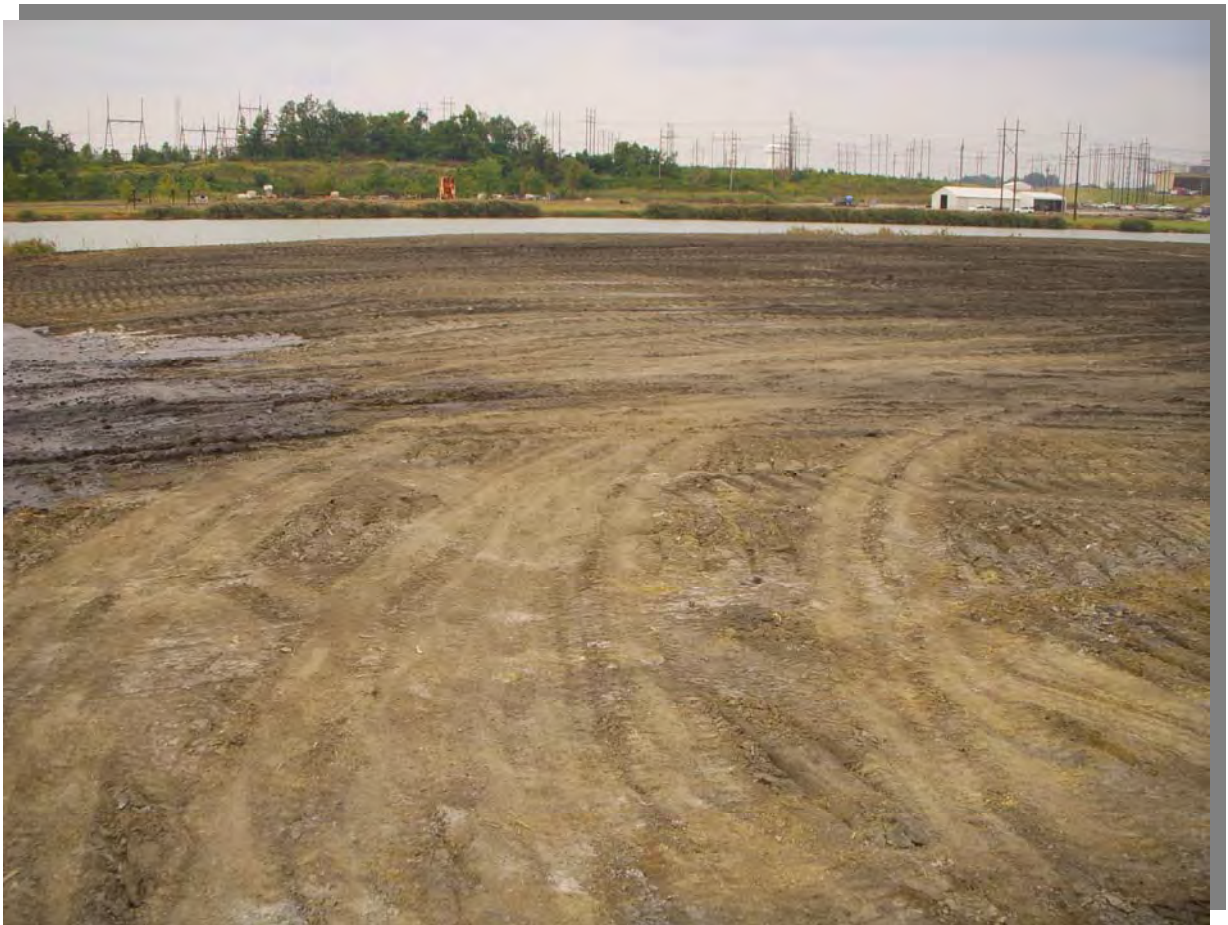
Photo 7 – View across the pond toward the west from the east side. Land in the foreground is former pond area that has been reclaimed with bottom ash.

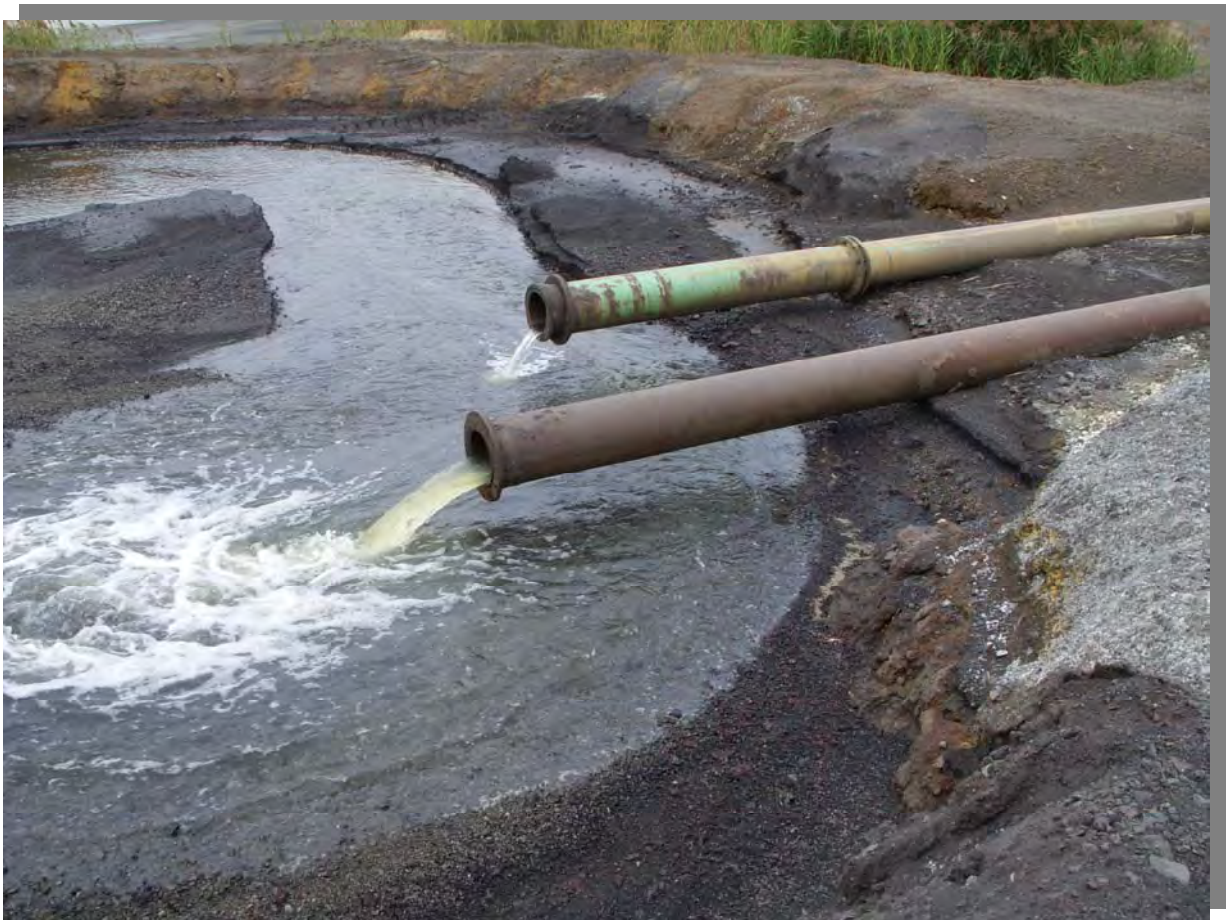
Photo 8 – Influent pipes discharging sluiced bottom ash into pond.

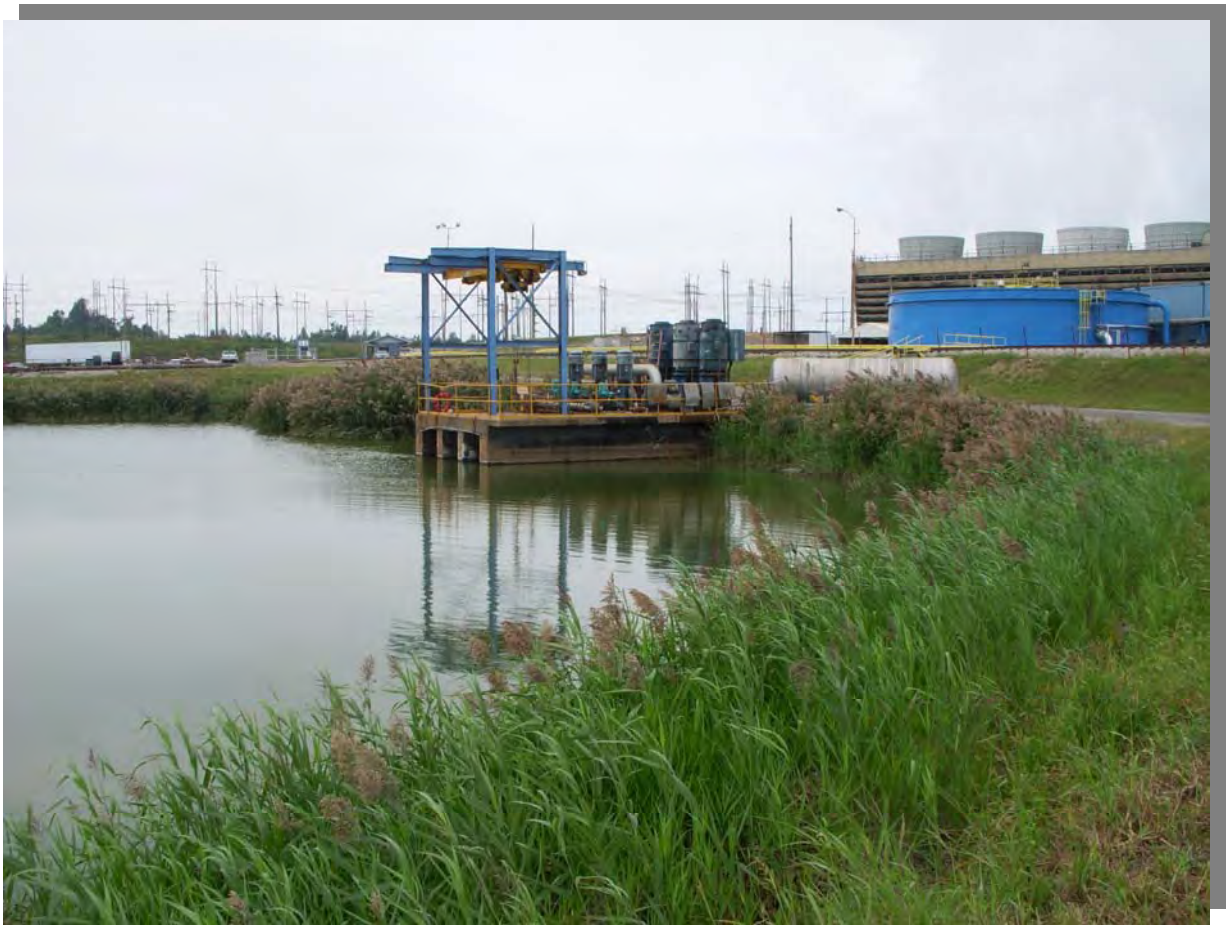
Photo 9 – View of pump station on incised inboard slope at the north end of the pond.
